First Results of Experimental Analysis of Stress State and Motion of Tram Gearbox Hinge

Ing. Martin Dub

Cílem práce je zmapovat stav napjatosti a pohyby závěsky nápravové převodovky částečně nízkopodlažní, šestinápravové tramvaje při reálných jízdních podmínkách. K tomuto účelu bylo použito měření pomocí odporových tenzometrů a také systém pro záznam a vyhodnocení pohybu Qualisys. V článku je popsána měřicí aparatura a její samotná instalace na zkoušenou tramvaj. Je zde také uveden postup měření včetně jednotlivých etap simulace reálného provozu, postup zpracování a vyhodnocení naměřených dat a zobrazení získaných výsledků.

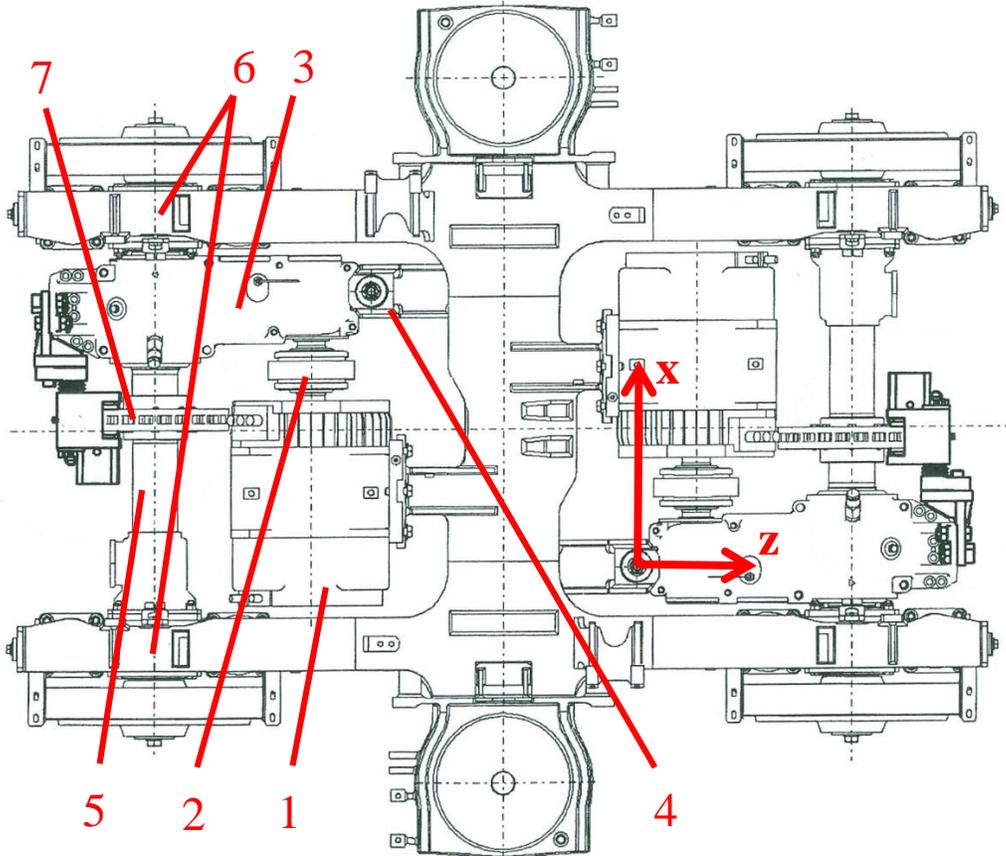
Fig. 1: Schema of the tram drive placed on the chassis – 1-Asynchronous motor, 2-Claw coupling, 3-Gearbox, 4-Gearbox hinge, 5-Mounted wheels, 6-Bearing units, 7-Disc brake

Tested tram is partially low-storeyed tram. It has three tractive chassis and it can reach the maximum speed of 60 km/h. Each chassis (Fig. 1) has two tractive mounted wheels, which are driven by partially spring-mounted drive. That consists of asynchronous motor of power 90 kW and two-gear reduction gearbox connected with claw coupling. Big gear of the gearbox is pressed on the axle of the mounted wheels, which is imbedded into bearing units. Their connection with the frame provide four rubber-metal cone springs, that create the primary springing of the tram chassis.

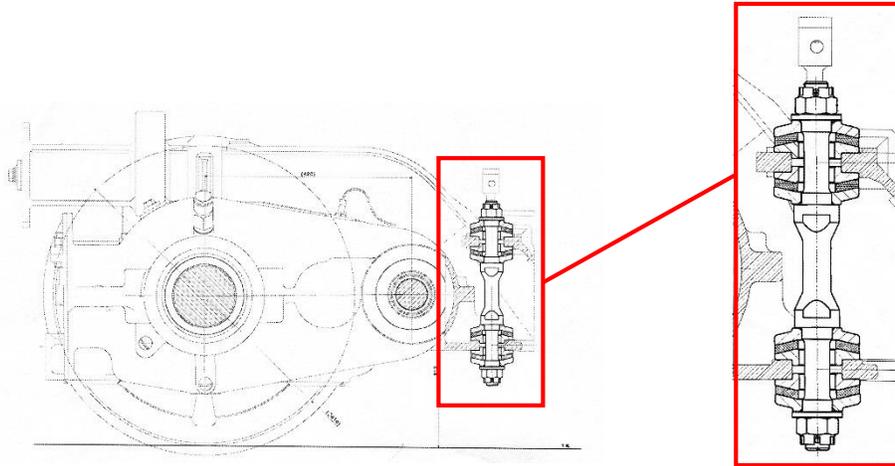
Fig. 2: Gearbox hinge design, [3]

The hinge of tested tram is designed as a round bar of diameter 28 mm imbedded into rubber supports as it is shown in Fig. 2. These should behave nearly as an ideal spherical joints so the hinge can catch only tension or pressure force. Any bending stress in the hinge is parasitic because it is caused by lateral forces which produce undesirable additional radial and axial loading forces for bearings of the output gearbox shaft (Fig. 3).

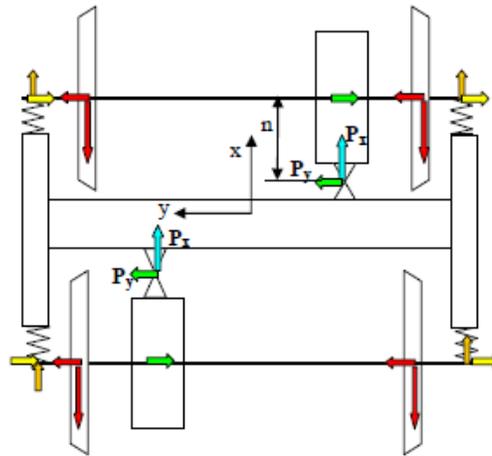
Fig. 3: Parasitic lateral forces, [3]

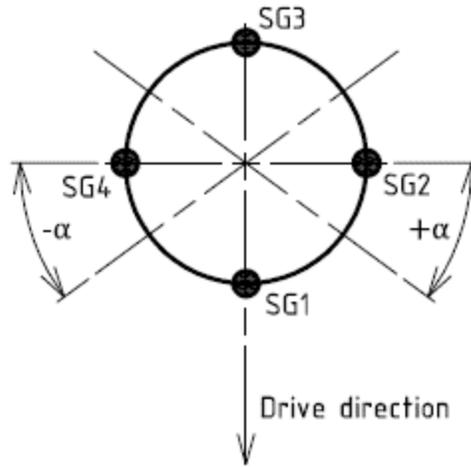
Fig. 4: Measuring arrangement of the strain gauges

Foil strain gauges are used to investigate stress state of the hinge. It is desirable to measure tension - pressure and bend simultaneously. Moreover the bend has to be find out in two perpendicular planes to obtain complete knowledge of the bend and the resultant including its orientation. The first plane is coincident with the tram drive direction (longitudinal plane) and the second is perpendicular and lies in the lateral plane of the tram. For measuring tension-pressure Wheatstone half-bridge arrangement has to be used due to bend compensation (i.e. two strain gauges). For measuring bend also Wheatstone half-bridge arrangement has to be used due to tension-pressure compensation (i.e. for measuring in two planes four strain gauges). To decrease quantity of strain gauges new arrangement is designed (Fig. 4.). Only four strain gauges are connected into four independent Wheatstone quarter-bridges with time synchronization.

This arrangement is very convenient because it is possible to measure tension-pressure like with full-bridge arrangement and simultaneously measure bending in two perpendicular planes like with half-bridge arrangements. Thanks to this improvement only four strain gauges has to be used, which spares not only the number of used strain gauges but also space and makes the connection of strain gauges easier. Acquired signals are obtained as strain from each strain gauge and they can be assembled after measurement like in corresponding Wheatstone bridges according to following formulas. Tension-pressure stress can be calculated from Wheatstone full-bridge formula.

Now the resultant and its orientation corresponding with Fig. 4 can be obtained.

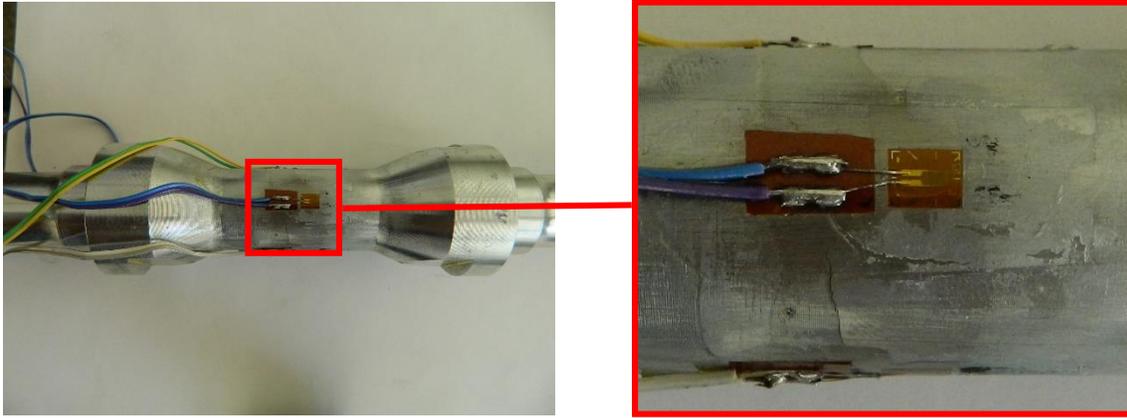
Fig. 5: Strain gauges installed on the hinge

Foil strain gauges are installed in the middle of the cylinder surface of the new unused hinge precisely after 90° as it is shown in Fig. 5. For this application self-compensative strain gauges with nominal resistance 120Ω are used. Moreover there is installed semiconductor thermal sensor for monitoring changes of the temperature during test drives. As the hinge is located in the chassis without any cover it is necessary to protect installed strain gauges against outside actions, e.g. water, dust or oil. It has to be protected also during mounting to the chassis. For this purpose short part of plastic tube is used (See Fig. 6) together with flexible putty which creates big enough chamber for strain gauges between the hinge and the plastic tube and also wires can pass through it. Thus adapted hinge is prepared for mounting into chassis of tested tram.

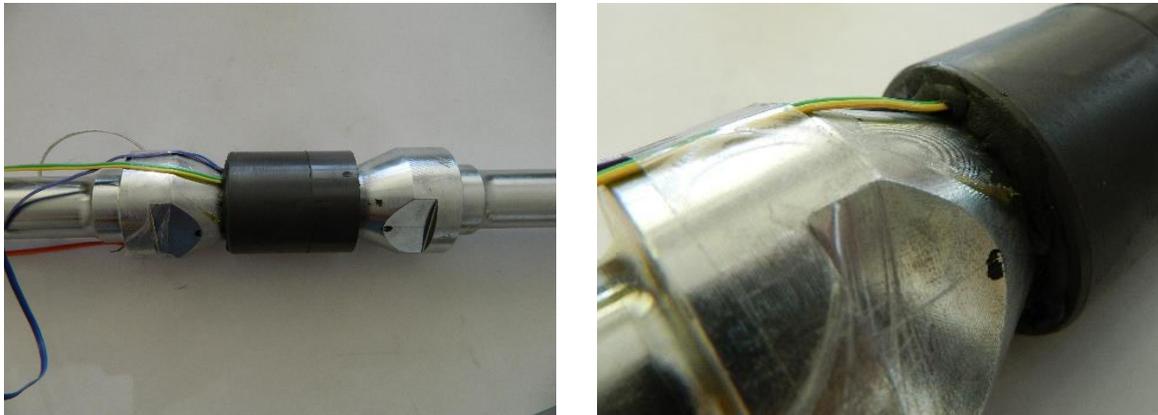
Fig. 6: Protective cover of the hinge with the strain gauges

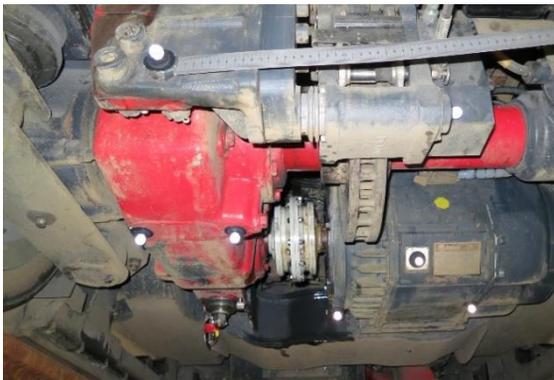
Fig. 7: Markers of the system Qualisys placed the gearbox and the asynchronous motor

In addition to measuring stress state of the hinge it is convenient to monitor relative motions of the gearbox connected with the mounted wheels to the frame of the chassis and to the asynchronous motor. Then it is possible to evaluate relative shifts and rotations of the output shaft of the asynchronous electromotor to the input shaft of the gearbox and required range of motions of claw coupling. For this purpose optical system for continual capturing and evaluating motions Qualisys is used. For tracking motions of the object it is necessary to use three cameras and three markers creating the reference plane on monitoring object. In this case six spherical markers are used, three are placed on the gearbox and remaining three are placed on the asynchronous motor (see Fig 7). In each object (gearbox and asynchronous motor) is thus created local Cartesian coordinate system (see Fig. 8). Furthermore another marker is placed on the axle of the mounted wheels to sample revolutions so the covered distance and current speed can be calculated.

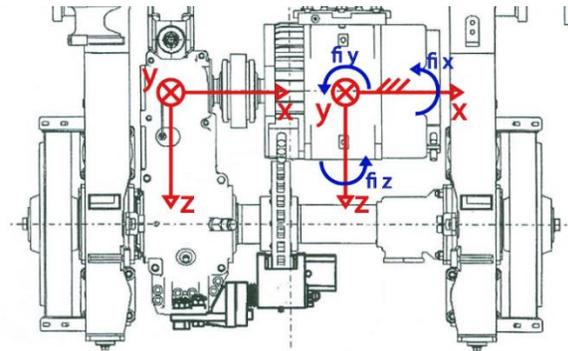
Fig. 8: Cartesian coordinate systems of the gearbox and the asynchronous motor

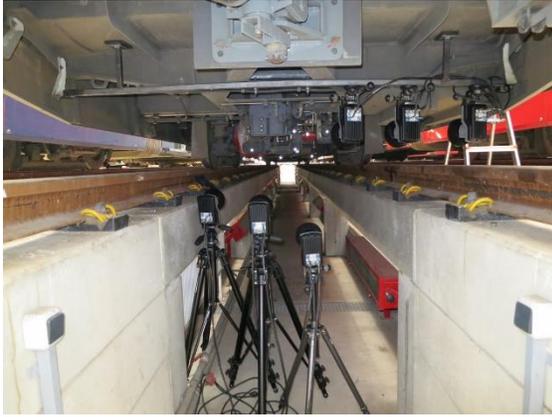
Fig. 9: Stationary and moving system of cameras

Altogether six cameras are used, they are divided into two subsystems – moving subsystem and stationary one. The first one is mounted on the special holder which is bolted to the tram frame so it moves with the tram. The second one is placed in the floor pit (See Fig. 9 and 10). The stationary system of cameras is there to verify accuracy of the moving system which could be influenced by the vibration of the tram frame. Both systems are calibrated together and time synchronized.

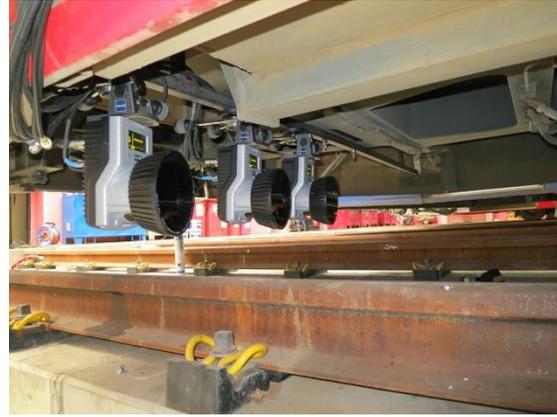
Fig. 10: Moving system of cameras mounted to the holder

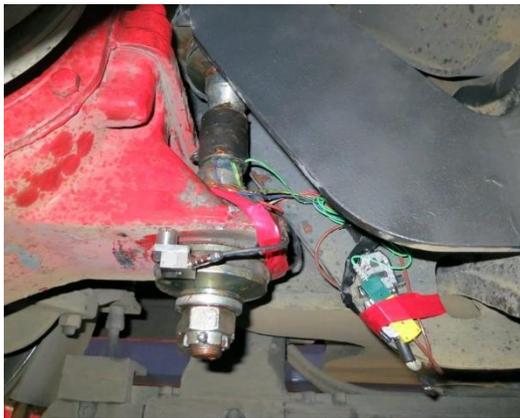
Fig. 11: Mounted and connected gearbox hinge

Measurement was carried out in the Motol Depot in Prague. The hinge with installed strain gauges and thermal sensor was mounted into rear mounted wheel of the rear chassis of tram tested tram (Fig. 11) and the wires were connected to the measuring central National Instruments placed inside the tram (Fig. 12). Sampling frequency was set for 2000 Hz. Both Qualisys cameras systems were installed as was described above (Fig. 9 and 10) and were connected to the Qualisys central also placed in the tram. Sampling frequency of Qualisys system was set for 500 Hz. Furthermore the torque of two asynchronous motors mounted to the chassis was recorded from the control unit of the tram to get the entire set of interesting values. Sampling frequency of the control unit is variable. All measuring centrals was manually time synchronized.

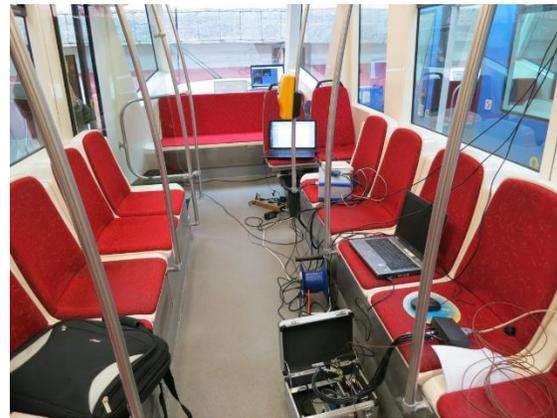
Fig. 12: Measuring central inside the tram

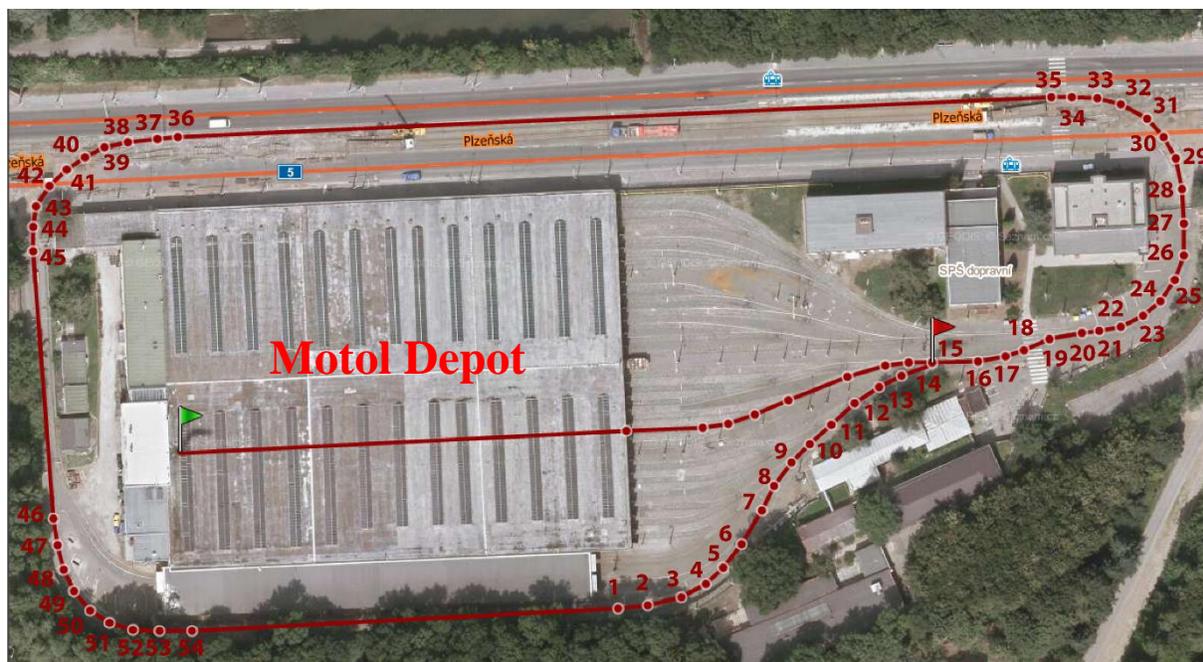
Fig. 13: Testing loop for common drive measurement

Test drive was divided into three regimes – maximal acceleration, maximal deceleration and common drive. Testing of maximal acceleration and deceleration was carried out inside the depot above the floor pit so the accuracy of moving cameras subsystem could be verified by the stationary subsystem. It has to be noticed that maximal deceleration was reached only by electrodynamic braking. Common drive was carried out on the loop inside and around the Motol Depot in total length of 721 m (Fig. 13). It is divided into smaller sections just for easier evaluation. These sections are described in Table 1. Measurement of the maximal acceleration and deceleration was accomplished three times and measurement of common drive twice. During all measurement was the tram empty except the driver and necessary measurement operators.

Section	Type	Points	Time [s]	Distance [m]
1	Left curve	2 – 6	7 – 17	7 – 35
2	Left curve	46 – 54	273 – 309	564 – 616
3	Left curve / crossing	7 – 15	19 – 35	45 – 102
4	Left curve / crossing	21 – 27	45 – 58	144 – 180
5	Left curve / crossing	29 – 35	96 – 160	197 – 233
6	Left curve / crossing	37 – 45	192 – 198	452 – 498
7	Crossing	6 – 8	16 – 20	35 – 52
8	Ess curve	37 – 46	37 – 46	113 – 146
9	Straight segment	35 – 36	159 – 192	233 – 447
10	Straight segment	45 – 46	197 – 274	498 – 564
11	Straight segment	54 – 1	309 – 339	616 – 721

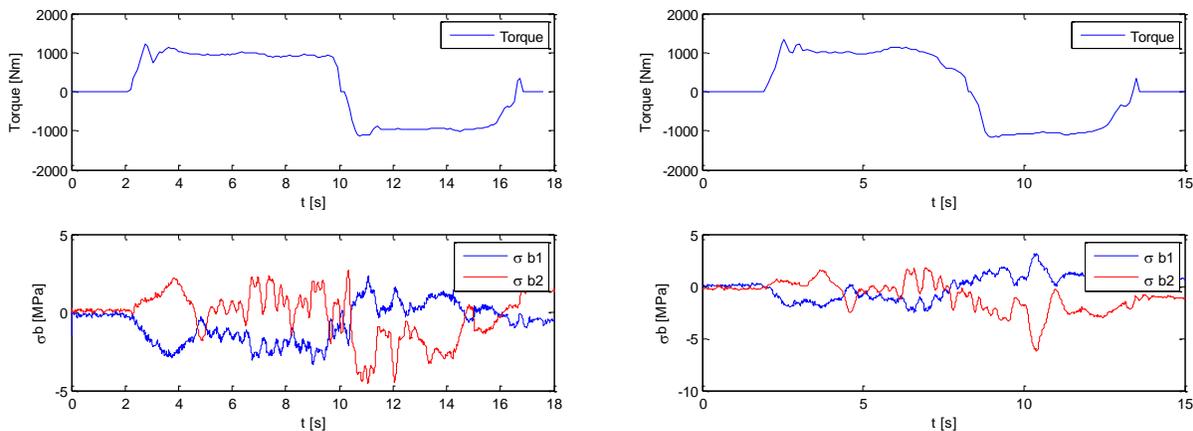
Fig. 14: Torque of two asynchronous motors and bending stress in two perpendicular planes for acceleration (left) and deceleration (right)

In above shown plots (Fig. 14 and 15) there is obvious that behaviour of monitored values is quite similar both for acceleration and for deceleration. During the acceleration regime the tram starts with the maximal acceleration to the maximum speed and decelerates gradually. During the deceleration regime the tram reach gradually the maximum speed and then the maximal electrodynamic braking is used. That's why the first half of the plots in case of acceleration regime and the second part in case of deceleration is more considerable. It is obvious that some amount of bending stress arises in the hinge during both acceleration and deceleration.

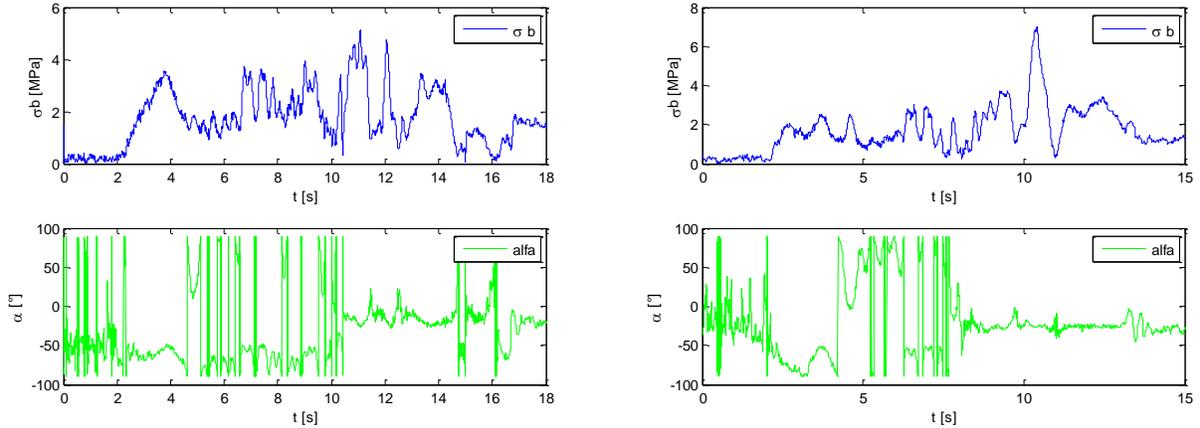
Fig. 15: Resultant of bending stress and its orientation for acceleration (left) and deceleration (right)

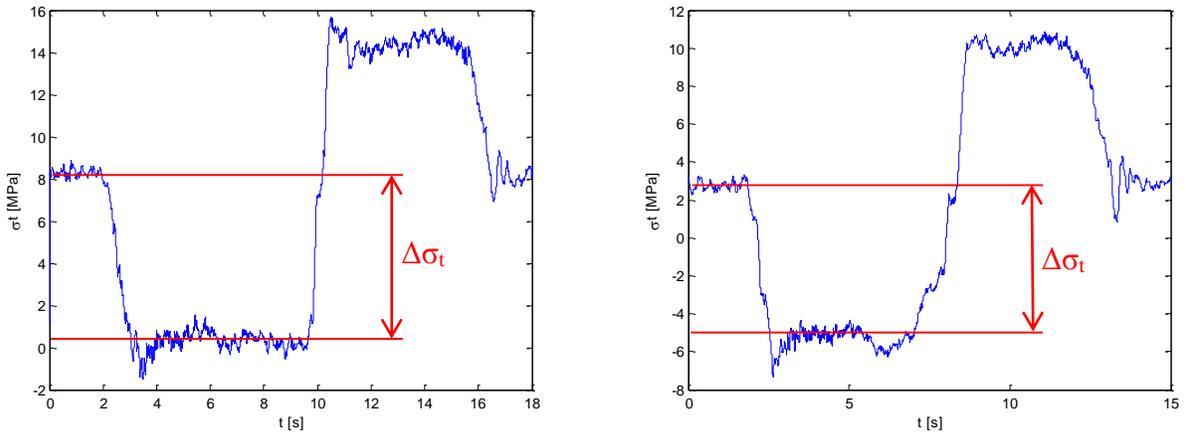
Fig. 16: Tensile stress in the hinge for acceleration (left) and deceleration (right)

In Fig. 16 there is behaviour of tensile stresses in the hinge. It can be seen that the tensile stress doesn't start at the zero stress. This indicates that some stress remains in the hinge even in unloaded state. These values aren't offset because they are changing during test drives. So it is necessary to evaluate only relative deviations of tensile stress $\Delta\sigma_t$, which in average reaches the value 7,8 MPa.

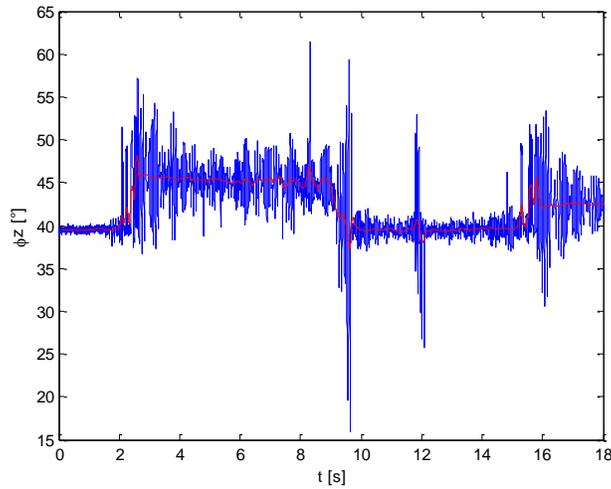
Fig. 17: Relative rotation of the gearbox to the asynchronous motor round the axis z for acceleration regime

In Fig. 17 there is shown rotation of the gearbox round the axis z during the acceleration regime. For better transparency red line is added. It is a representation of mean value during the time. The average deviation of the angle ϕ_z during the acceleration (time about 2 s – 9 s) is 5° .

the gearbox hinge was mounted exactly with specified pretension so the rubber bedding isn't so rigid and the hinge allows bigger movements of the hinge. This hypothesis is proved by data measured by system Qualisys (Fig. 17 and 22). These plots show that the relative rotation ϕ_z of the gearbox to the asynchronous motor are higher than admissible values for the claw coupling. So it can cause damage of the coupling.

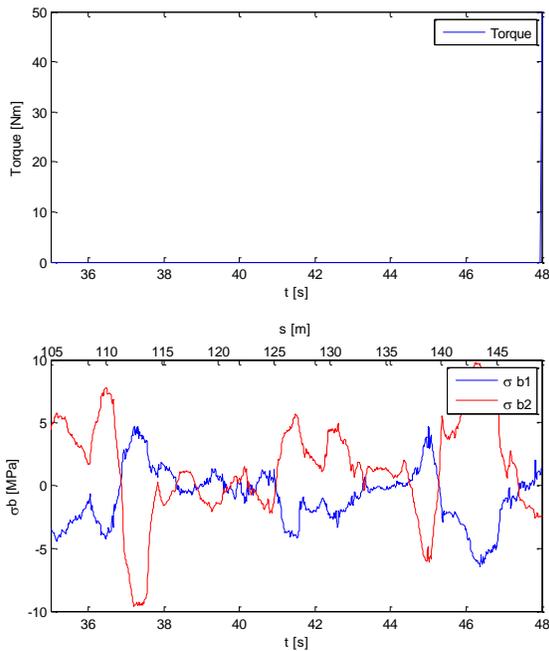
Fig. 18: Torque of two asynchronous motors and bending stress in two planes

This section were passed through only by drifting (without bringing in the torque). In spite of this fact even in this regime bending stress occurs in the hinge (Fig. 18 and 19). In the Fig. 20 there is shown the instantaneous velocity of the tram calculated from the revolutions of the axle. These revolutions were determined from the motion of the marker applied on the axle.

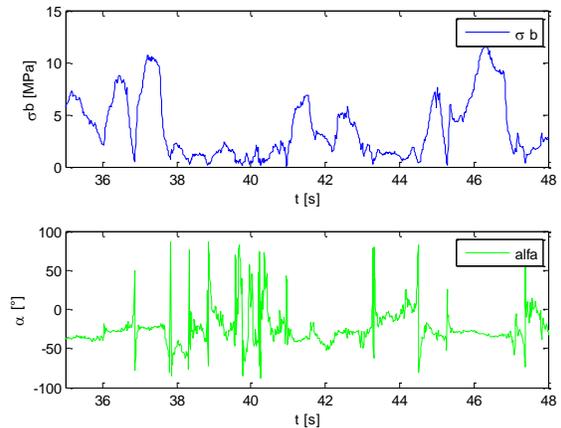
Fig. 19: Resultant of bending stress and its orientation

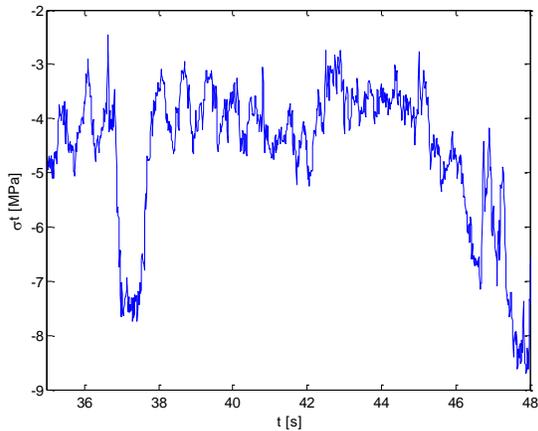
Fig. 20: Tensile stress in the hinge

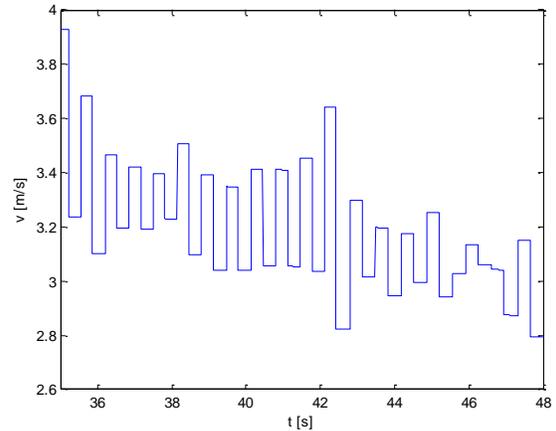
Fig. 21: Instantaneous velocity of the tram

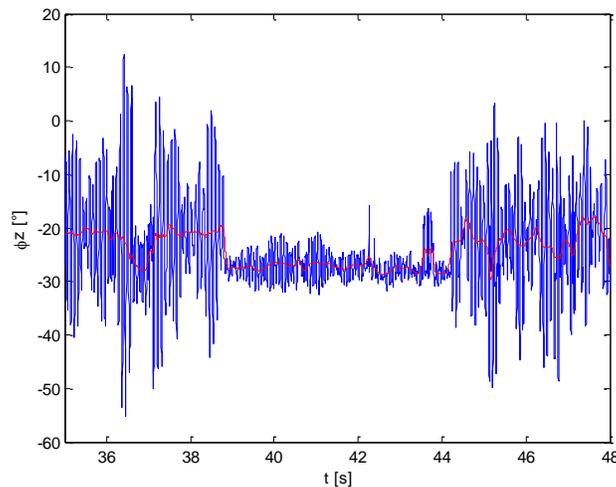
Fig. 22: Relative rotation of the gearbox to the asynchronous motor round the axis z for common drive regime, section with ess curve

In the Fig. 22 there is once again the demonstration of data acquired from the system Qualisys. In this case the average deviation of the angle ϕ_z during the passage through the ess curve is $6,5^\circ$.
